FINAL REPORT

EVALUATION AND ASSESSMENT CUTLER ELEMENTARY SCHOOL 31 S. WINCHESTER STREET SWANZEY, NEW HAMPSHIRE

FOR
MONADNOCK SCHOOL DISTRICT
SAU #93, SWANZEY, NEW HAMPSHIRE
JUNE 30, 2017

The H.L. Turner Group Inc.

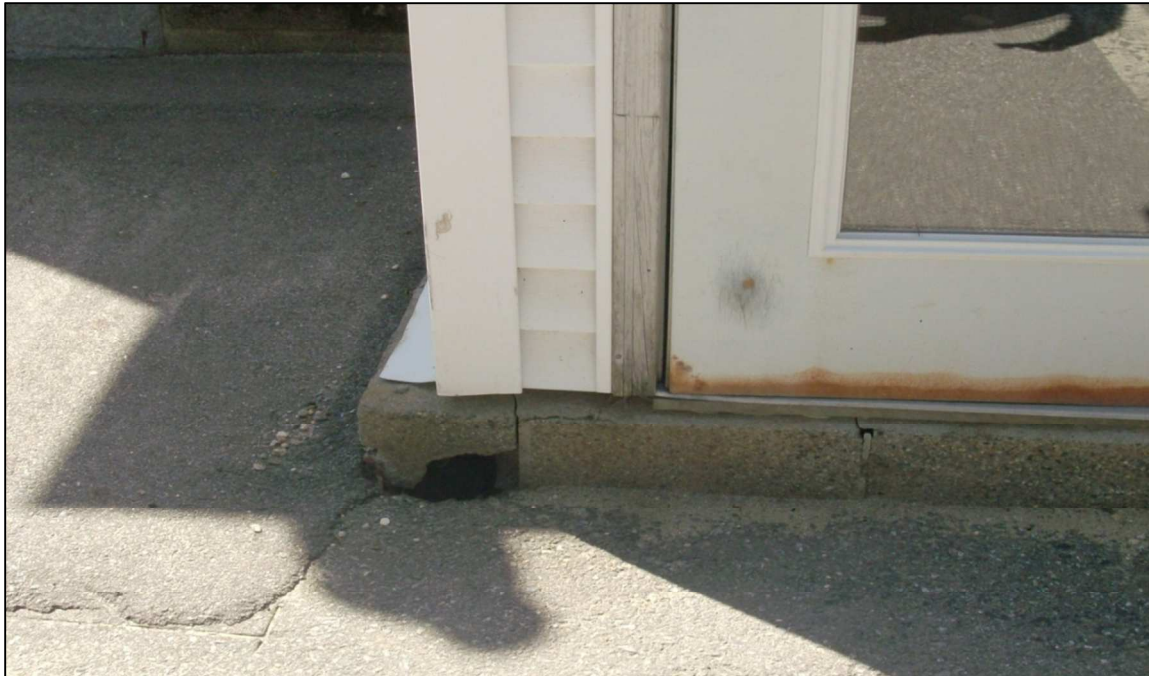
At the northeast corner there is a walk-up stair to grade from the basement literary room. The door at the top of the stairs is badly rusted at the base, presumably from splash back of rain on the asphalt. There is a visible gap in the corner of the foundation of the stairway and it appears water is able to enter into the foundation wall unimpeded at this spot. In addition, the door opens directly into a vehicular circulation path. In fact, there is a stop sign mounted to the side of the stair enclosure indicating how close it is to the vehicular pathway. At the north wall of this structure where it joins to the 1945 addition, runoff from the pitched roof of the original building sheds onto the face of the masonry wall. There is heavy staining and mortar joint deterioration of the brick at this point. A gutter and downspout, or additional crickets should be considered for this location. We observed some minor mildew growth evident on the vinyl siding at the north wall.

Exit from the basement level of the original school. Note rusted door and hole in foundation.

- Rebuild the stairs on the northwest corner of the building such that it is in compliance with current codes. (\$12,000)
- Repair the gap in the foundation at the stairway exit from the literary room. Replace the door. (\$5,000)

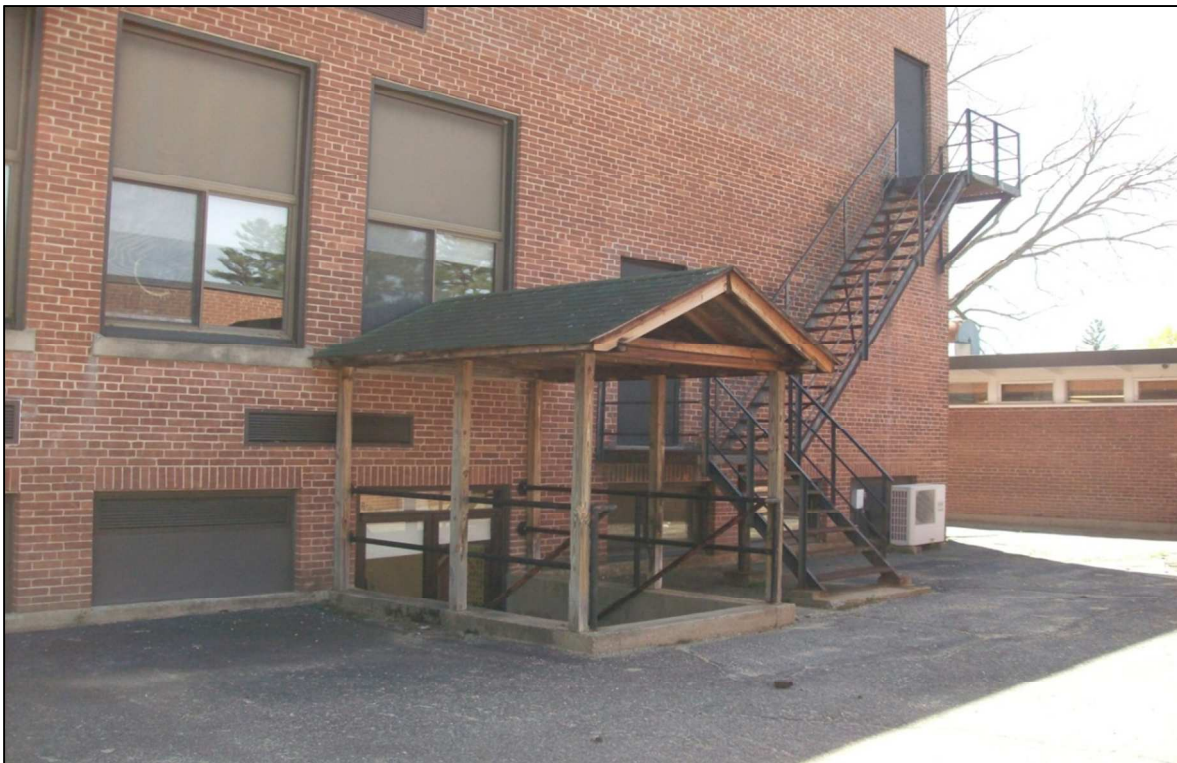
There is a canopy over the walk-up stairs from the basement library. This is built of pressure treated lumber that hasn't been painted or stained. The post bases show signs of discoloration and much of the pressure treatment may have leached out. The posts should be continually monitored for deterioration and rot.

There are exits from the rear of the 1945/1950 additions via a door onto a steel framed platform with a set of steel framed stairs. These are used only in the event of an emergency. At some point in the near future, the stairs will require close inspection for corrosion and weld cracks, and will require a new coating of paint.

Wood framed canopy over basement exit. Also steel fire exit stairs from first and second floors.

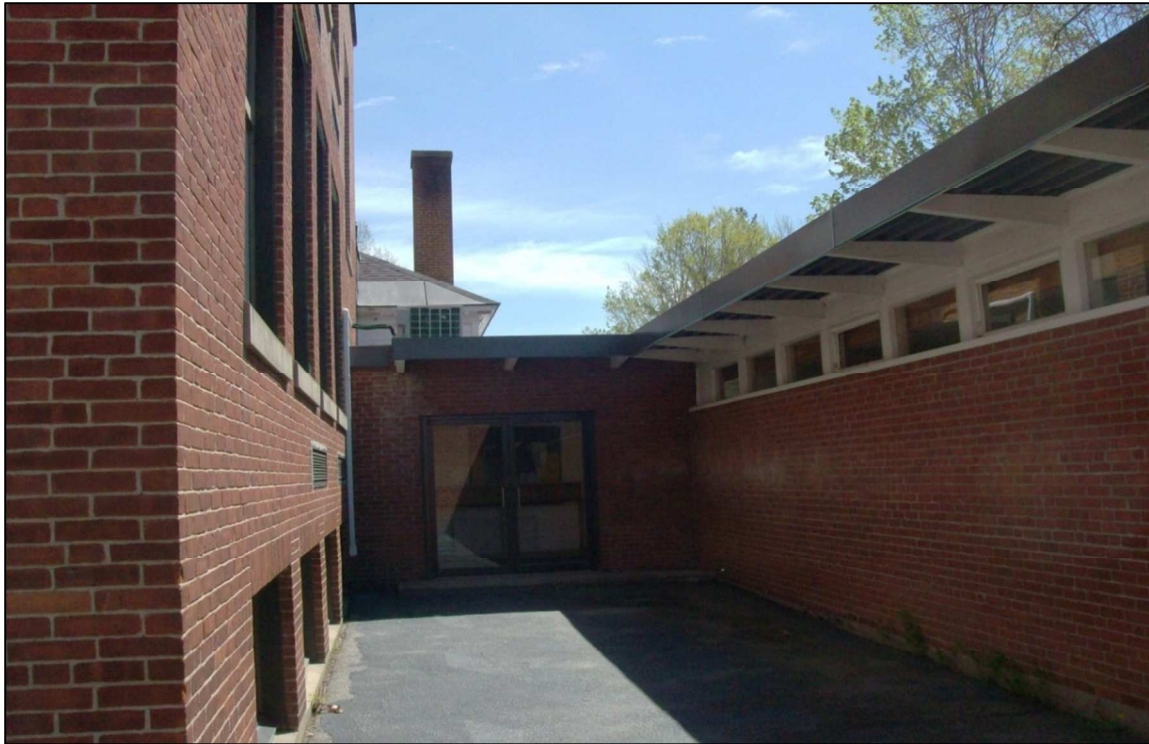
On the east facing wall of the 1970's addition near the main entry, we observed some staining, most likely from moisture, at the base of the wall from possible splash back from the asphalt. Also the north side of the 1970's addition has a roof overhang supported by a series of tapered wood beams that support the metal roof deck. Some of the outriggers have peeling paint and should be checked up close for decay or deterioration.

Paved courtyard between the 1945/1950 and 1970 additions.
Note overhanging wood roof support beams.

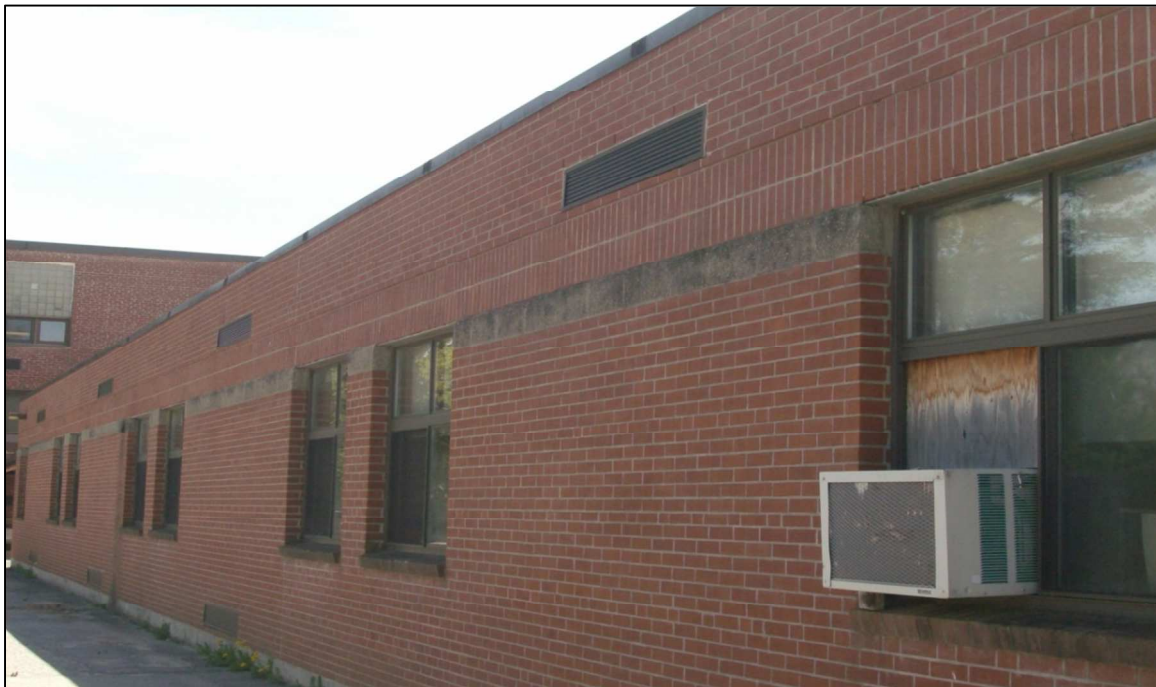
At the 1996 addition, the north-facing walls of the gym and kitchen show mildew and moisture staining. No efflorescence is evident, but there may be trapped moisture in the cavity that is not drying out. On the north wall of the 1996 classroom addition there is a split face CMU accent band in the brick veneer. At various locations it appears water drips over the gravel stop at the roof and hits the projected split face block. We observed moss growing on the split face block and staining above and below on the brick veneer. There was some slight efflorescence on the masonry veneer in these spots as well. Efflorescence is a crystalline deposit on the surface of the masonry. These are deposits of salts that originate in the mortar or block itself, and when combined with moisture, are driven by pressure differences through the porous masonry to the surface. As the water evaporates it leaves the salt deposits behind.

North façade of 1990's wing. Note staining on precast accent piece and individual AC unit.

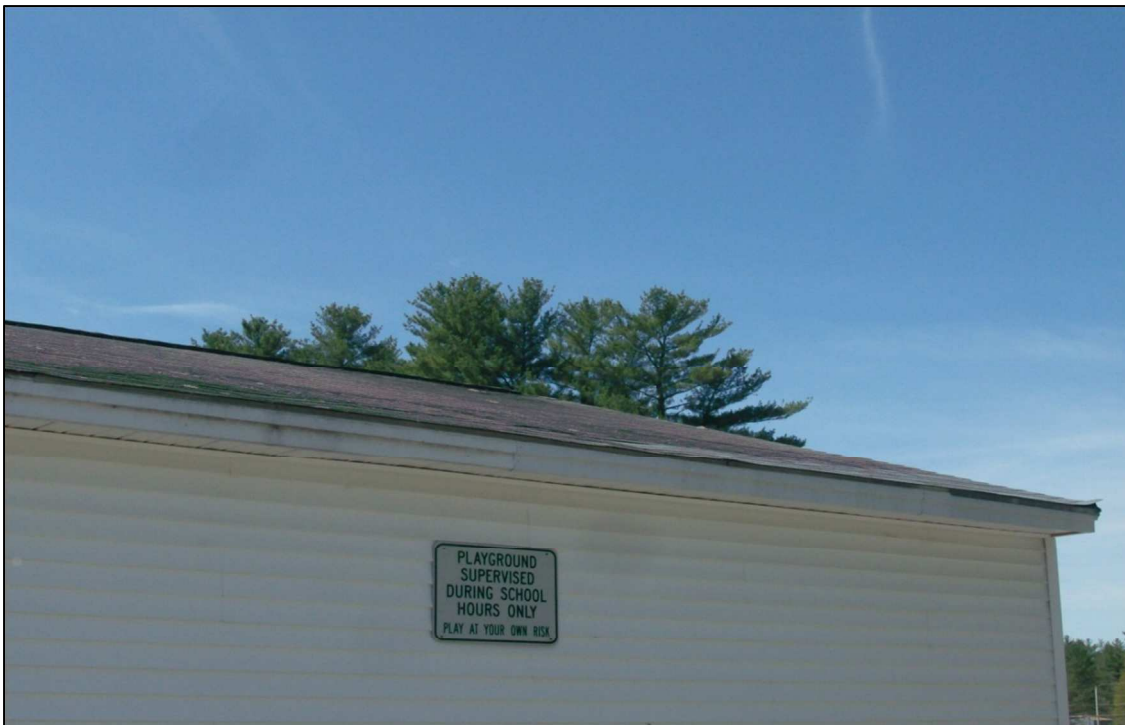
There are two wood framed, modular style classrooms that were moved from a remote location on the school grounds to a position off the west side of the 1996 addition. The units are situated on a concrete perimeter frost wall with interior footings and piers. The area below the portable units is a crawlspace and there are some small vents on the sides of the units. But unless there is sufficient air movement, the floor framing of the portable is likely suffering from mold growth and possible wood decay. The exterior of the modular units are vinyl covered with a shingled roof. The roof is in poor condition and is in need of replacement. There is heavy mildew build-up on the north face of one of the units. The entrance to the modular units includes a wood ramp for handicap accessibility. Judging by the age and overall condition of the modular units, it is our opinion that they are past their useful life and should be replaced sooner than later with permanent classrooms.

Shingle roof of portable units nearing end of life.

- Replace the modular classroom with an addition onto the school. (\$500,000 to \$600,000)
- Investigate the cupola support and provide a more substantial support system (\$6,000)

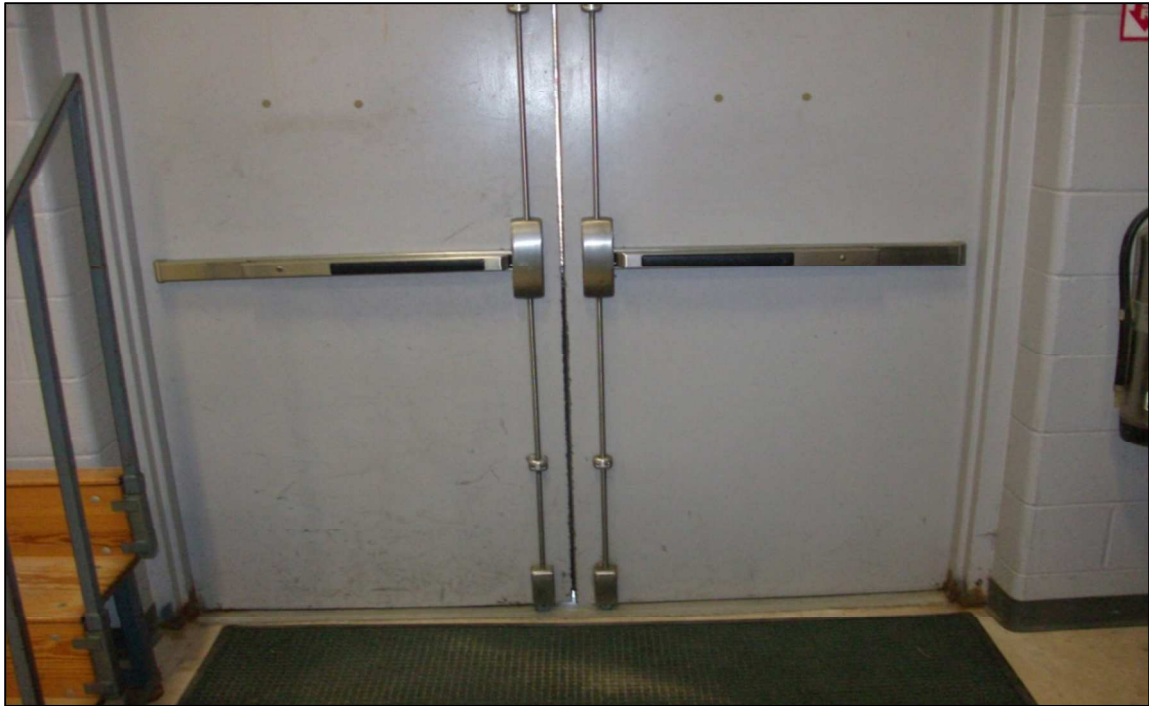
The gymnasium and kitchen are part of the 1996 addition. Both are in good condition. The gym has a seamless vinyl/rubber sheet product which is in good condition. However, the lines on the floor are badly worn and require repainting. Another item requiring attention includes the double doors; they are lacking astragal seal strips to cover the space between door halves. There is also some corrosion at the bottom of the door frames and the doors will have to be replaced in the next five to six years. The gym heating and ventilation is provided by two large ceiling mounted units. The units are over 20 years old and may need replacement in the next five to six years. Having the units suspended from the ceiling presents some difficulties in terms of ease of access for maintenance purposes.

Doors at gym. Note lack of astragal between doors and corrosion at door frame.

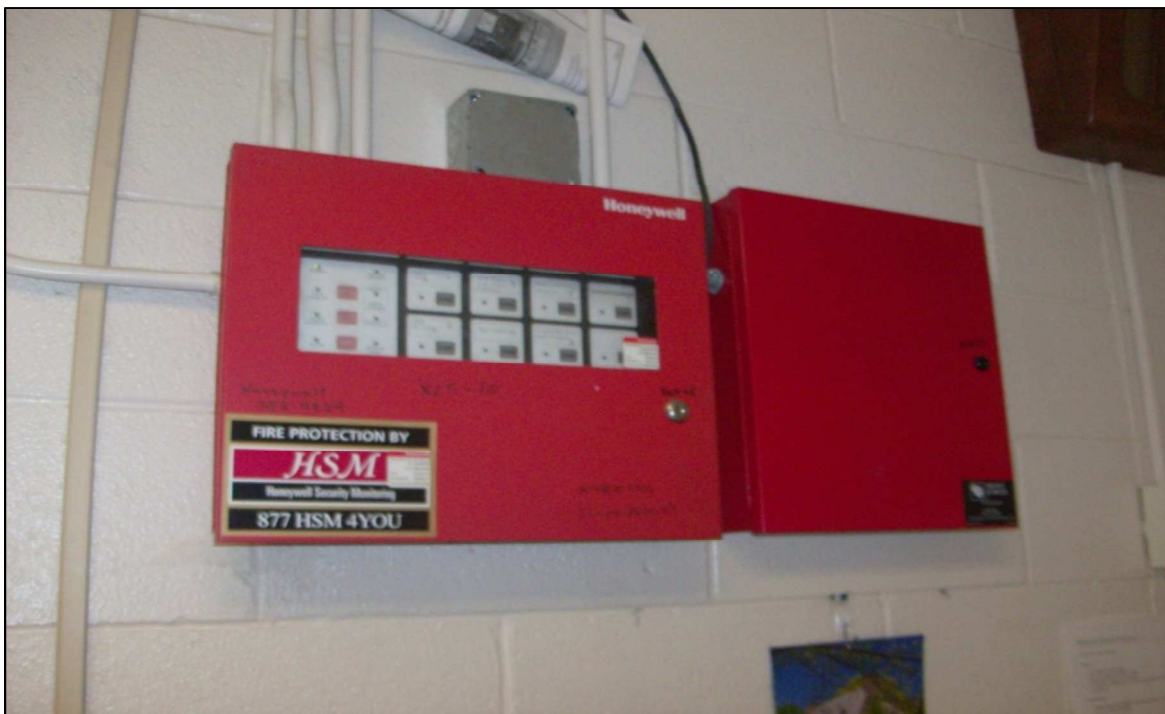
The building is fully covered by a sprinkler system. There are heat and smoke detectors throughout the building, as well as horns and strobes. However there is a lack of horns and strobes in some of the bathrooms. Also the fire alarm panel is outdated and should be upgraded.

Fire alarm panel needs upgrade to new modern addressable panel.

- Update the fire alarm panel (\$75,000)
- Re-paint the lines on the gymnasium floor (\$3,000)
- Clean soot/creosote from chimney (\$1,500)

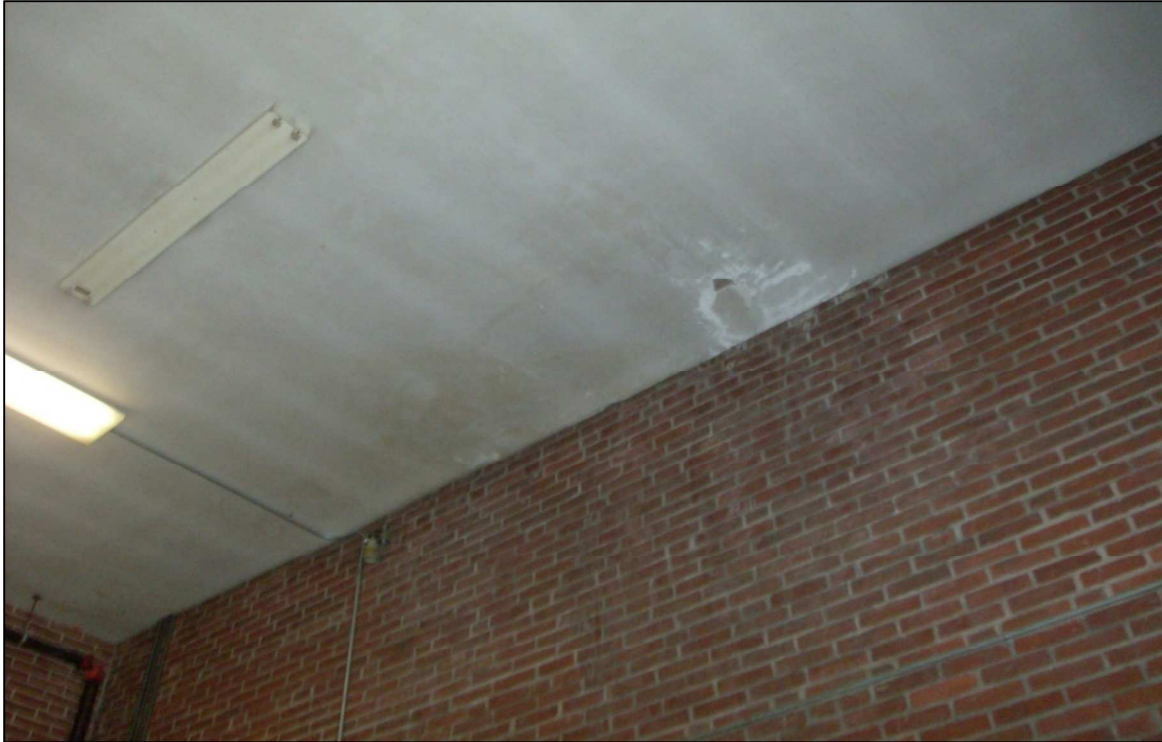
Most of the ceilings are suspended, or drop ceilings, with acoustical tiles. The ceilings appear to be in good shape throughout the early 1970's and 1997 addition. There is some staining in the main corridor tiles of the 1970's building, possibly from roof leaks in this area. In the original building some of the foam backed acoustical ceiling tiles have rips and tears in the vinyl facing at several locations. The ceiling in these areas should be replaced. In this same area, the classrooms and some hallway areas have plaster ceilings. In some areas we observed staining and hair line cracking.

Staining on ceiling of stairwell between 1945/1950 and 1970's additions.

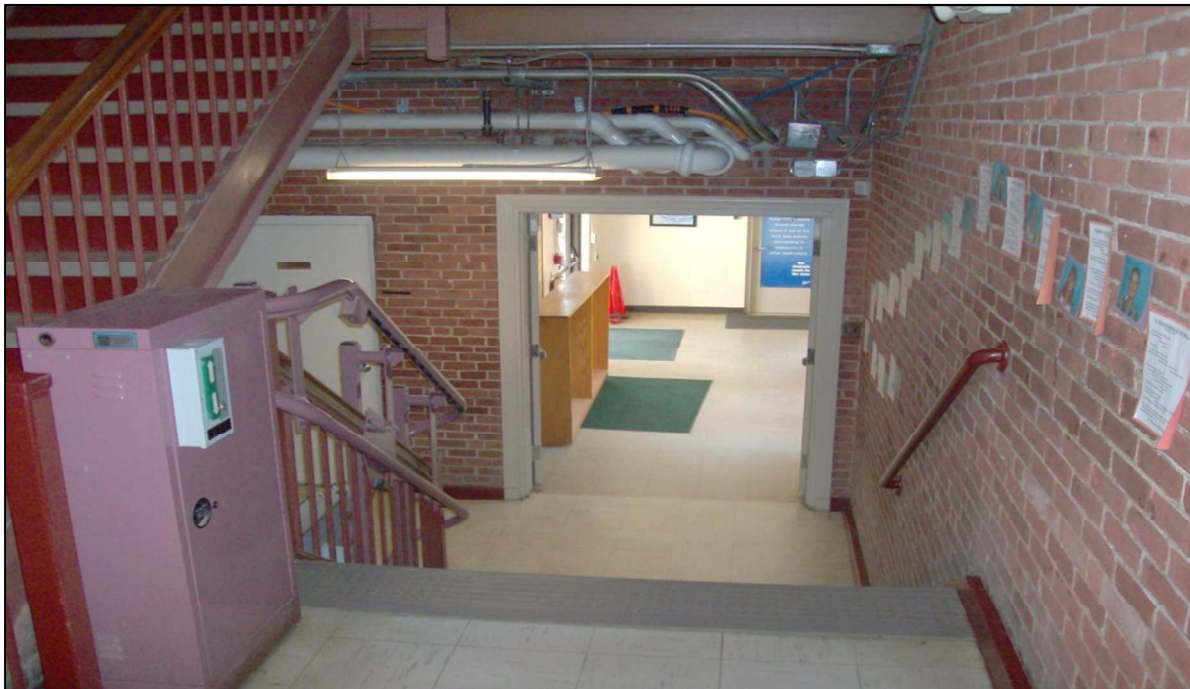
Accessibility – There is a stair mounted chair lift from the main entry at the 1970's building to the first floor and basement of the 1945 addition. There is no accessibility to the second floor (1950 addition) classrooms, or any of the original wood structure classrooms. The original wood structure is down several risers from the floor of the 1945 wing. The 1970's and 1996 additions are fully accessible with on-grade entrances and a ramp into the modular classrooms, both from the interior floor level change and parking lot outside. There are accessibility issues with the bathrooms as previously mentioned.

Stairway to library in basement of original section of school.
Note chair lift from basement to first landing. It does not extend above that level.

- Install horns and strobes in the bathrooms to meet code (\$15,000)
- Provide access to the second floor of the 1950's addition by extending the stair mounted chair lift or by providing an elevator. (\$25,000 to \$300,000)
- Modify the main stairway handrail to meet the code requirements for guiderail height, handrail extensions and a wall mounted handrail. (\$20,000)
- Inspect the steel fire escape stairways and platforms and re-paint (\$12,000)
- Replace the doors and frames in the Gymnasium (\$5,000)
- Upgrade the bathrooms to include proper ADA compartments (\$75,000)
- Window replacement in the 1945, 1950's and 1970's sections of the building (\$250,000 to \$300,000)

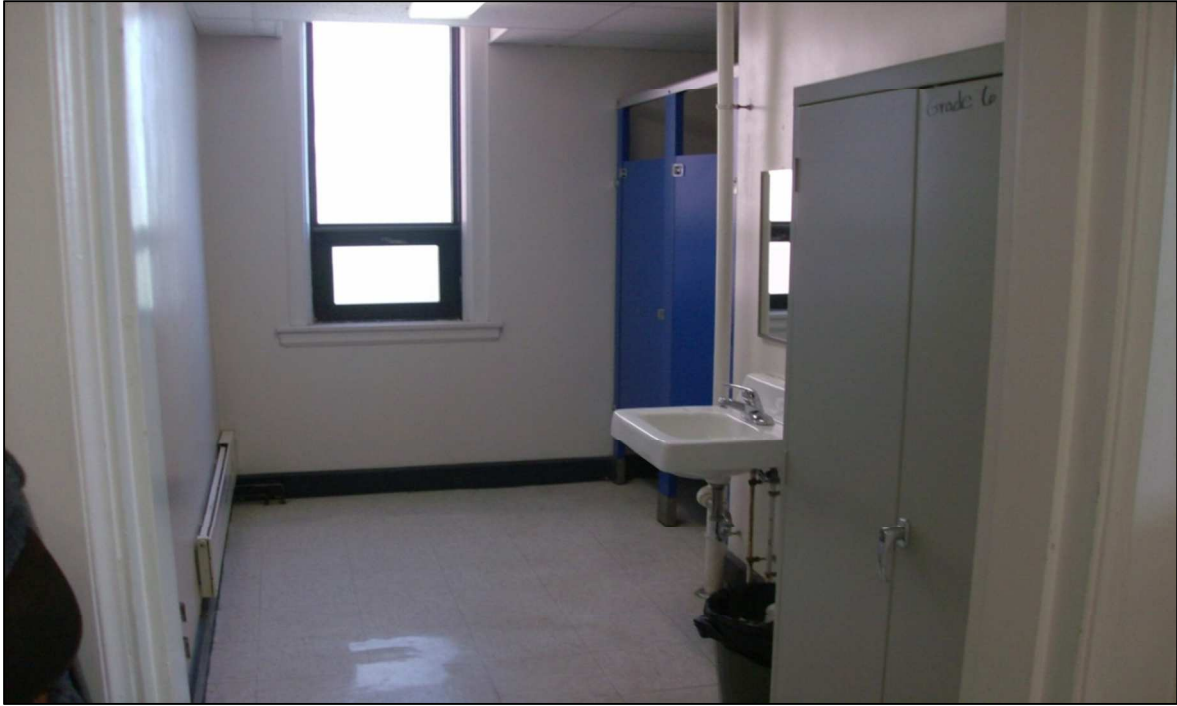
There is a shortage of ADA toilet compartments. Current codes require at least one accessible compartment in every toilet room where compartments are provided. Only two bathrooms in the 1997 addition comply. There are three toilets shown to be accessible on the 1997 addition drawings; however, they do not meet current accessibility guidelines.

Typical bathroom in 1945/1950 addition. There is a lack of fully accessible stall.
