Re: 3-Year AHERA Reinspection
RPF File No.: 209912

RPF Environmental, Inc. (RPF) conducted an asbestos reinspection for the Monadnock Regional School District on June 10, 2020 with EPA Asbestos Hazard Emergency Response Act (AHERA) requirement. The reinspection included a visual inspection of the areas known to contain asbestos-containing building materials (ACBM) and assumed ACBM, as stated in the AHERA inspection records provided to RPF for review.

Buildings included in this reinspection included Monadnock Regional High School (MRHS), Mt. Caesar Elementary School, Wilcox, Cutler Elementary School, Troy Elementary School, George Emerson Elementary School, Sullivan Elementary School, Gilsum Elementary School, and the S.A.U. 93 Administration Building.

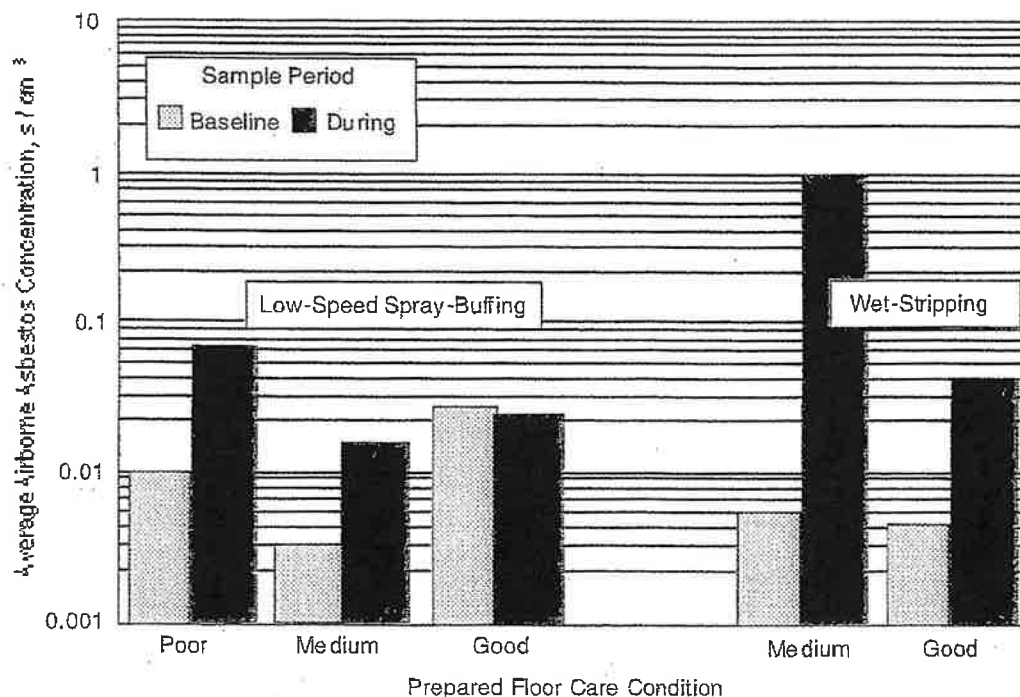
Figure 1 illustrates the overall average (geometric mean) concentrations measured before and during low-speed spray-buffing and wet-stripping on floors in prepared floor conditions. Although the mean relative increase in airborne asbestos concentrations during low-speed spray-buffing tended to decrease as the floor care condition improved (i.e., poor condition resulted in a larger relative increase than medium, and medium condition showed a larger relative increase than good), the differences between the three levels of floor care were not statistically significant ($p=0.1149$). Overall, the average airborne asbestos concentration during low-speed spray-buffing was approximately 2.6 times higher than the average baseline concentration. This increase was statistically significant ($p=0.0017$). A 95% confidence interval for the mean airborne asbestos concentration during spray-buffing as a proportion of the baseline concentration showed that the overall mean airborne asbestos con-

Figure 1. Average airborne asbestos concentrations during low-speed spraying of floors in prepared conditions.

- 2) The average airborne asbestos concentration measured during low-speed spray-buffing of floors in the three levels of prepared floor-care conditions (poor, medium, and good) was approximately 2.6 times higher than the average baseline concentration. This increase was statistically significant.

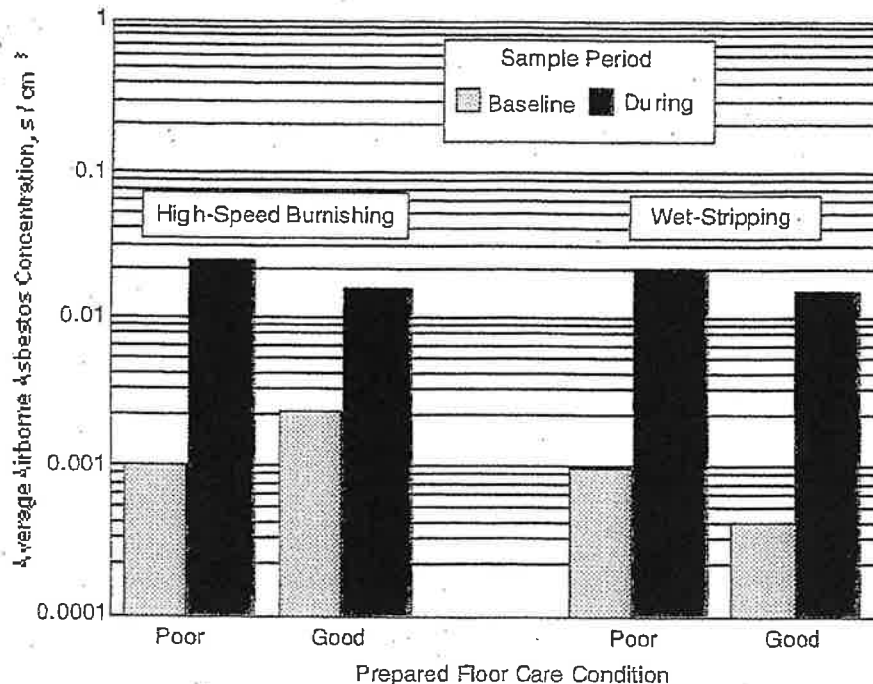
Figure 2. Average airborne asbestos concentrations measured before and during ultra high-speed burnishing and wet-stripping of floors in prepared conditions.

TWA concentrations measured during wet-stripping (after ultra high-speed burnishing) exceeded the OSHA PEL of 0.1 f/cm³ for total fibers, all of the 8-hr TWA concentrations measured during ultra high-speed burnishing exceeded the OSHA PEL. These exceedances, however, were due to the excess nonasbestos-containing particulate generated during the burnishing process and not to elevated airborne asbestos particles.

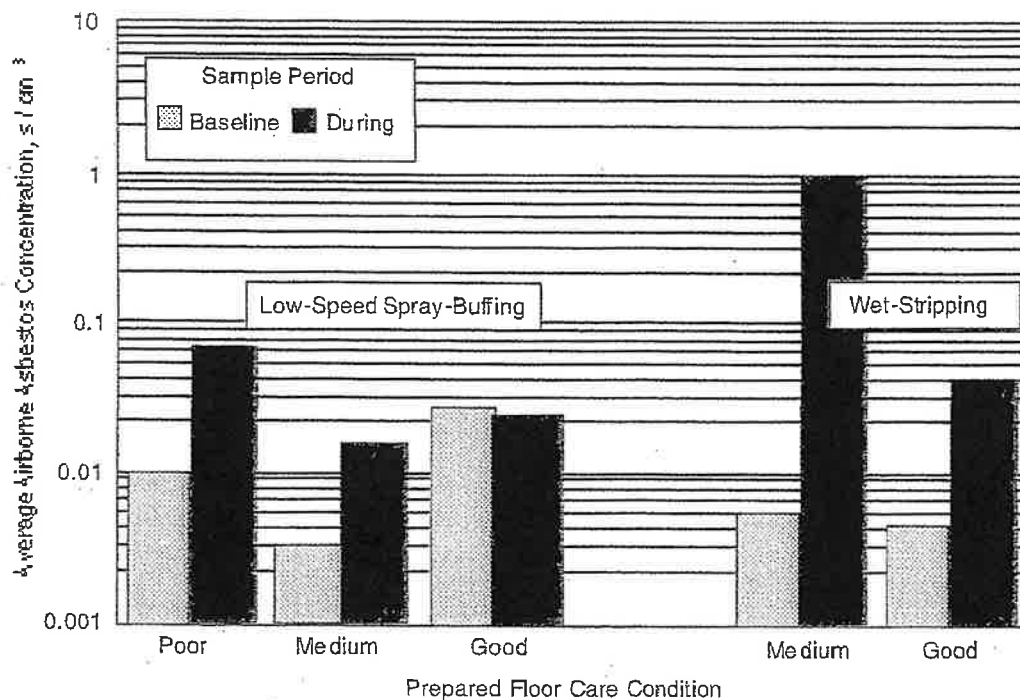
Figure 1 illustrates the overall average (geometric mean) concentrations measured before and during low-speed spray-buffing and wet-stripping on floors in prepared floor conditions. Although the mean relative increase in airborne asbestos concentrations during low-speed spray-buffing tended to decrease as the floor care condition improved (i.e., poor condition resulted in a larger relative increase than medium, and medium condition showed a larger relative increase than good), the differences between the three levels of floor care were not statistically significant ($p=0.1149$). Overall, the average airborne asbestos concentration during low-speed spray-buffing was approximately 2.6 times higher than the average baseline concentration. This increase was statistically significant ($p=0.0017$). A 95% confidence interval for the mean airborne asbestos concentration during spray-buffing as a proportion of the baseline concentration showed that the overall mean airborne asbestos con-

Figure 1. Average airborne asbestos concentrations during low-speed spraying of floors in prepared conditions.

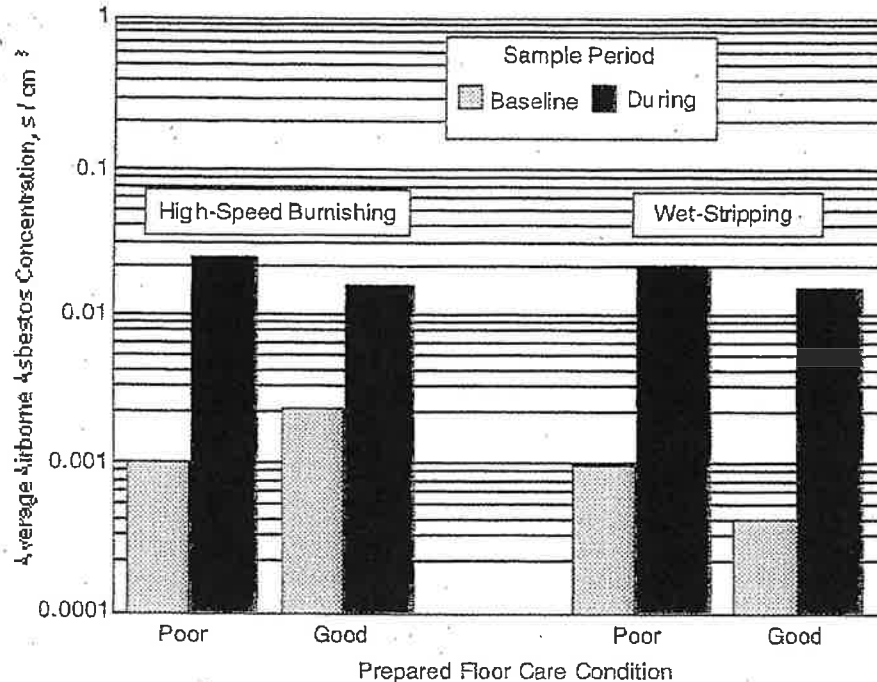
Figure 2. Average airborne asbestos concentrations measured before and during ultra high-speed burnishing and wet-stripping of floors in prepared conditions.

TWA concentrations measured during wet-stripping (after ultra high-speed burnishing) exceeded the OSHA PEL of 0.1 f/cm³ for total fibers, all of the 8-hr TWA concentrations measured during ultra high-speed burnishing exceeded the OSHA PEL. These exceedances, however, were due to the excess nonasbestos-containing particulate generated during the burnishing process and not to elevated airborne asbestos particles.

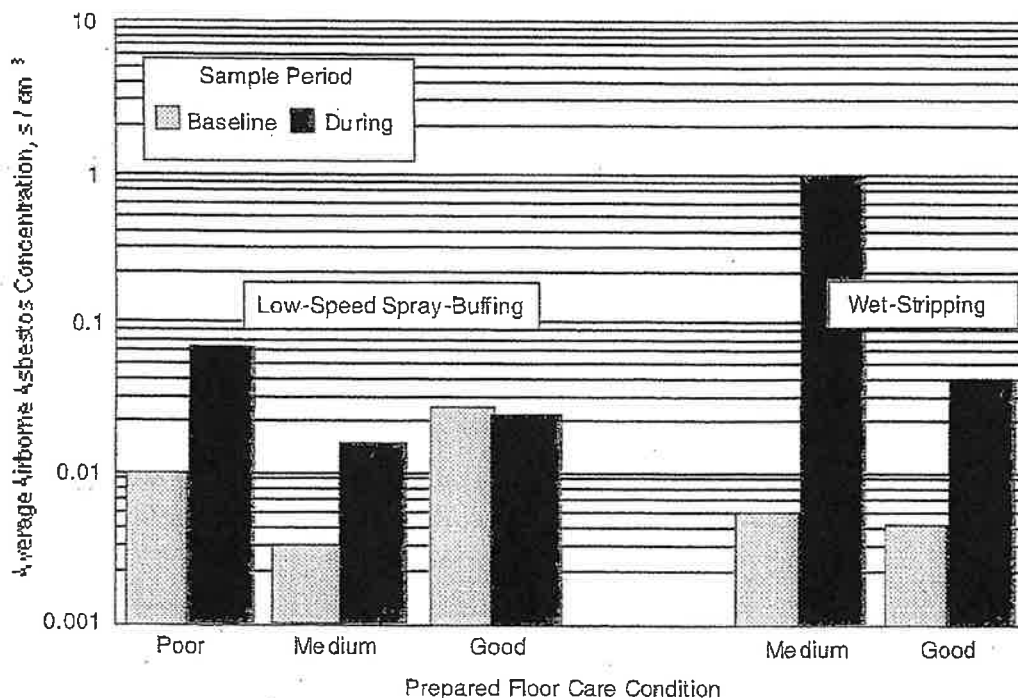
Figure 1 illustrates the overall average (geometric mean) concentrations measured before and during low-speed spray-buffing and wet-stripping on floors in prepared floor conditions. Although the mean relative increase in airborne asbestos concentrations during low-speed spray-buffing tended to decrease as the floor care condition improved (i.e., poor condition resulted in a larger relative increase than medium, and medium condition showed a larger relative increase than good), the differences between the three levels of floor care were not statistically significant ($p=0.1149$). Overall, the average airborne asbestos concentration during low-speed spray-buffing was approximately 2.6 times higher than the average baseline concentration. This increase was statistically significant ($p=0.0017$). A 95% confidence interval for the mean airborne asbestos concentration during spray-buffing as a proportion of the baseline concentration showed that the overall mean airborne asbestos con-

Figure 1. Average airborne asbestos concentrations during low-speed spraying of floors in prepared conditions.

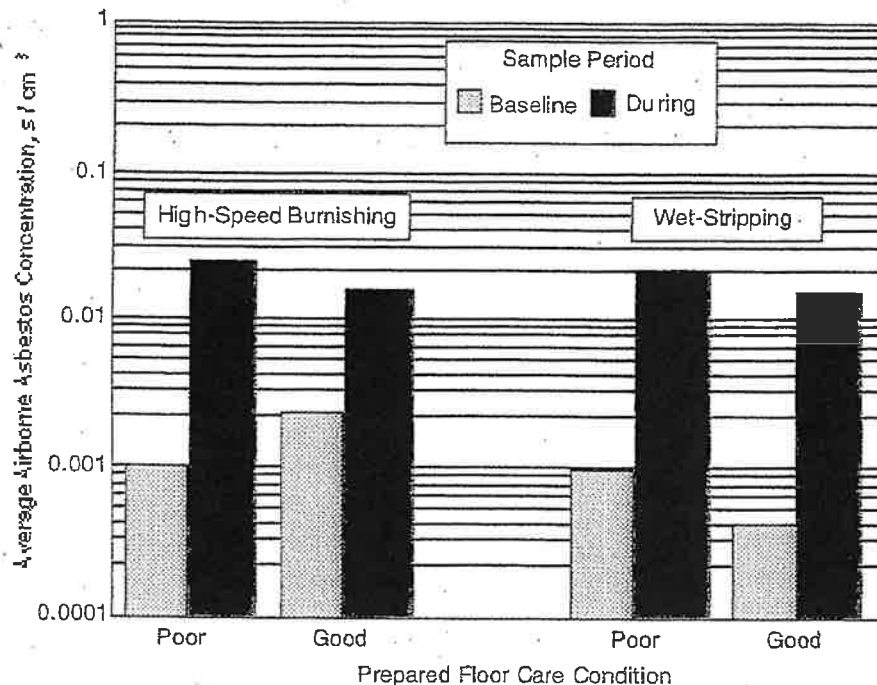
Figure 2. Average airborne asbestos concentrations measured before and during ultra high-speed burnishing and wet-stripping of floors in prepared conditions.

TWA concentrations measured during wet-stripping (after ultra high-speed burnishing) exceeded the OSHA PEL of 0.1 f/cm³ for total fibers, all of the 8-hr TWA concentrations measured during ultra high-speed burnishing exceeded the OSHA PEL. These exceedances, however, were due to the excess nonasbestos-containing particulate generated during the burnishing process and not to elevated airborne asbestos particles.
